# Development of a New Beam Intensity Monitor Prototype

Julia Redinger

*SY-BI-XEI, CERN*

(Dated: August 22, 2025)

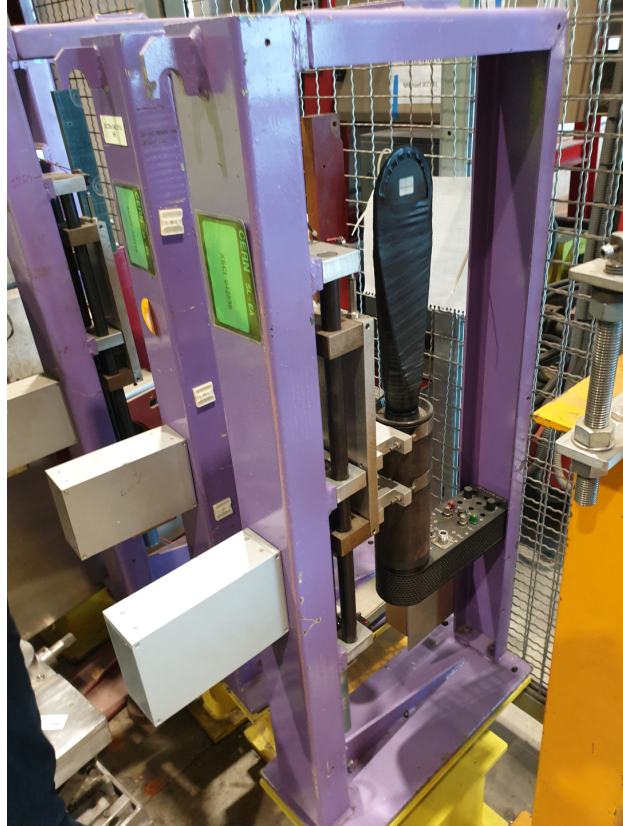
FIG. 1: Current XSCI monitor used for measuring beam intensity [3]

The existing XSCI monitor uses a plastic scintillator paddle placed in the beamline. Through the scintillation process [6], photons are generated by the charged particles in the beam, and pass through a series of light guides. These capture the photons and keep them in the system with the principle of total internal reflection. The scintillator is coupled to a PMT (photomultiplier tube) which collects the photons. The data collected can then be analyzed and intensity calculations can be performed [3]. See Figure 1 for an image of the current XSCI monitors.

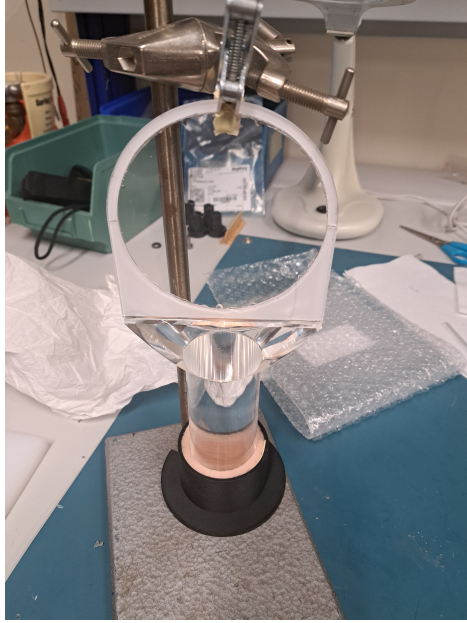
FIG. 6: The configuration to glue the top optical assembly to the smooth light guide.

To glue the top assembly (scintillator disk + flat light guides) to the smooth light guide, a clamp assembly was put together to hold the top assembly in place on the smooth light guide. This was done with two clamps (to achieve the required angle), with foam taped to the inside of the clamp to prevent scratches on the top assembly. A base was also 3D printed and lined with foam to hold the fishtail light guide in place and also prevent it from getting scratched. Note that a ‘notch’ was taken out of this base to get it close enough to the clamp stand.

Once again, the glue was mixed and a thin glass capillary was used to put a line of glue on the fishtail light guide (which was in the 3D printed base). The top assembly was clamped at the correct angle, and then lowered onto the light guide. This final configuration can be seen in Figure 6.

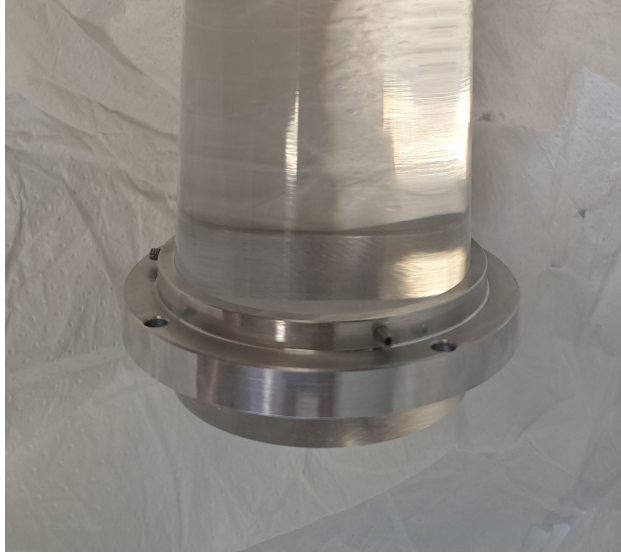
FIG. 8: The ring clamp on the bottom of the fishtail light guide.

After the optical components were glued together, the entire assembly could be put together. First, the ring clamp could be put on the base of the light guide. The ring clamp can be seen in Figure 8. This clamp must be placed at the correct height and orientation so that the scintillator is perpendicular to the beam, and the nuts can be screwed onto the clamp properly. There are 3 small set screws that can be tightened to hold this clamp in place.

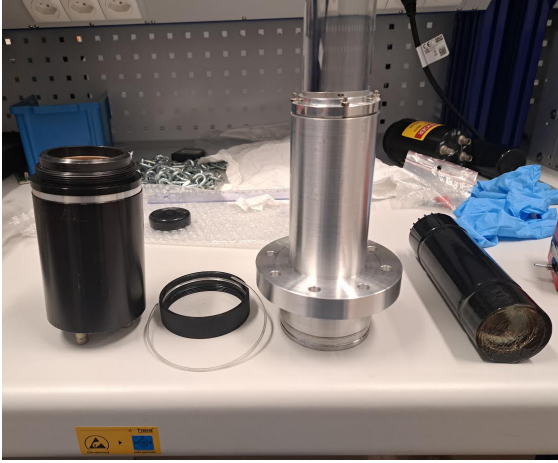
(a) From left to right: the PMT base, the screw ring to connect the PMT to the window assembly, the window assembly (with the light guide attached), and the PMT.

Next, the PMT and base need to be connected to the optical window assembly. These components can be seen in Figure 9a, where the components from left to right are the PMT base, the screw ring to connect the PMT to the window assembly, the window assembly (with the light guide and scintillator assembly attached), and the PMT. The window assembly (which can be seen in Figure 9b) houses the PMT and the optical window that acts as the vacuum-air interface.

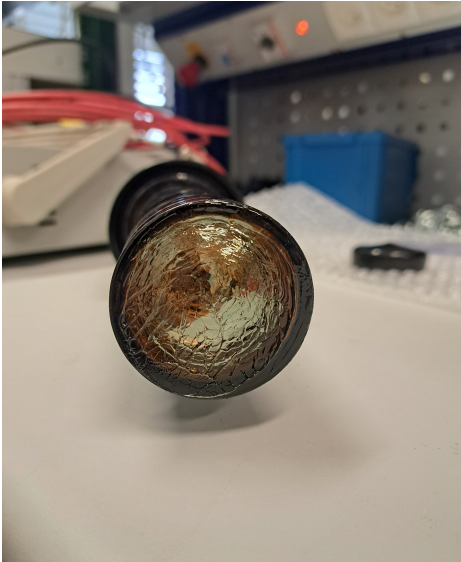
(c) The PMT photocathode with a layer of optical grease.

The PMT can simply be inserted into the PMT base. A coat of optical grease was then applied to the photocathode of the PMT (see Figure 9c), to help couple it to the optical window. The screw ring can be screwed onto the PMT base as well. Finally, the optical window assembly can be partially screwed into the screw ring on the PMT base. It is screwed in until the groove in the optical window assembly lines up with the holes in the screw ring - the clear plastic ring can then be inserted into the groove through the hole, which will hold the whole assembly together. See Figure 9d.

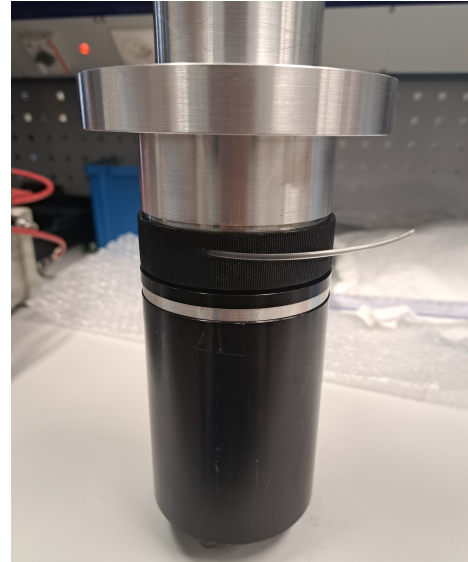
(d) The PMT base attached to the window assembly, with part of the clear ring used to connect them sticking out for demonstration.

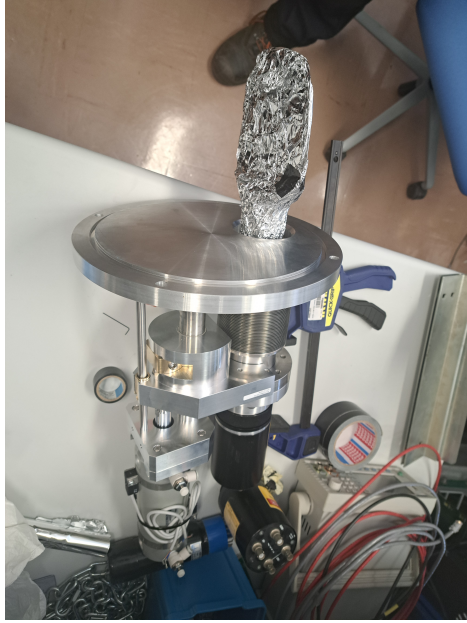
FIG. 10: The completed assembly, including the PMT and its base, the scintillator and light guides, and the motor and bellows.

After coating the bottom of the light guide in another even coat of optical grease, it can be put on the optical window and the nuts can be put on. Finally, the assembly can be put on the large circular flange. The completed assembly can be seen in Figure 10.
